IN RE: ETHICON, INC., PELVIC REPAIR SYSTEM PRODUCTS LIABILITY LITIGATION	Master File No. 2:12-MD-02327 MDL 2327 JOSEPH R. GOODWIN U.S. DISTRICT JUDGE
THIS DOCUMENT RELATES TO: <i>Wave 3 Cases</i>

Intentional Oxidation of Prolene Mesh

Supplemental Report of Dr. Shelby F. Thames

August 8, 2016

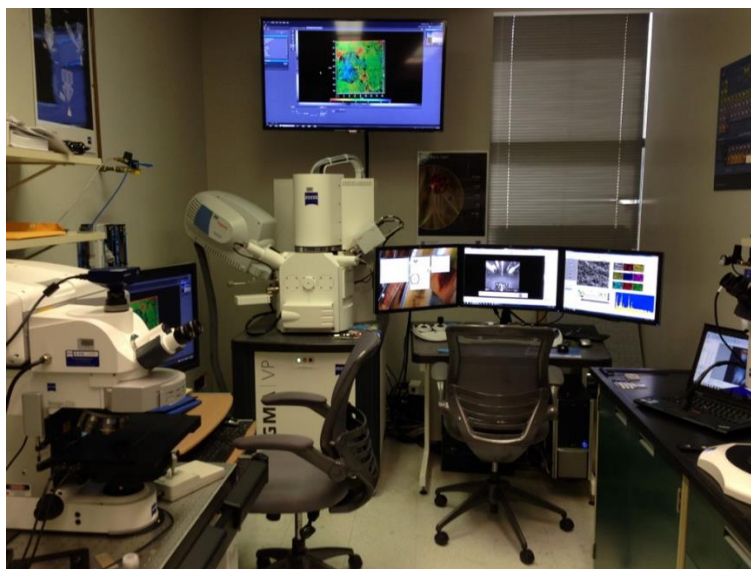
Digital microscopy and scanning electron microscopy (SEM) of the before and after fiber exposure samples were conducted with a Keyence VHX-600 digital microscope (Figure 9) and a Zeiss Sigma VP FEG-SEM (Figure 10). One can readily observe the oxidation effects upon Prolene as demonstrated by light microscopy and SEM images (Figures 11 and 12) of fibers; before and after UV exposure. As a result of UV exposure as described herein, Prolene fibers were grossly embrittled and demonstrated deep cracks resulting in fiber rupture via crack propagation.

Figure 10. Zeiss Sigma VP FEG-SEM
